# **FMEA - Mitigating hazard risk in MRD**

***Proactive Risk Assessment and effective Implementation of Mitigating measures***

Dr Shweta Prabhakar

Fortis Hospital Mohali

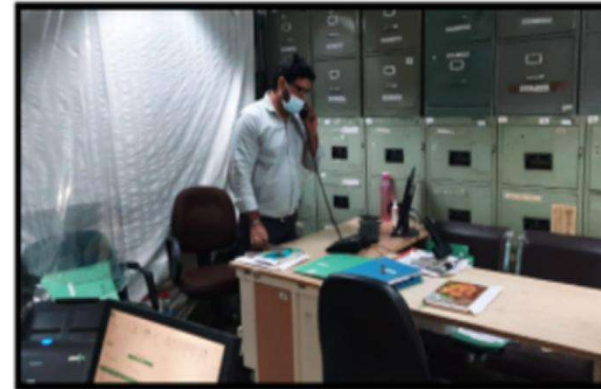
Staff informing Code Red at EPBAX

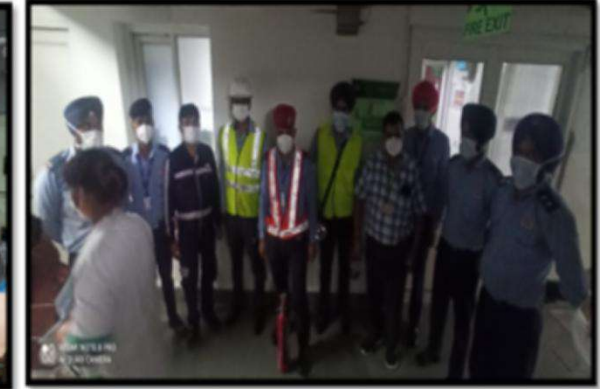
Team Security Post Code Red Mock Drill

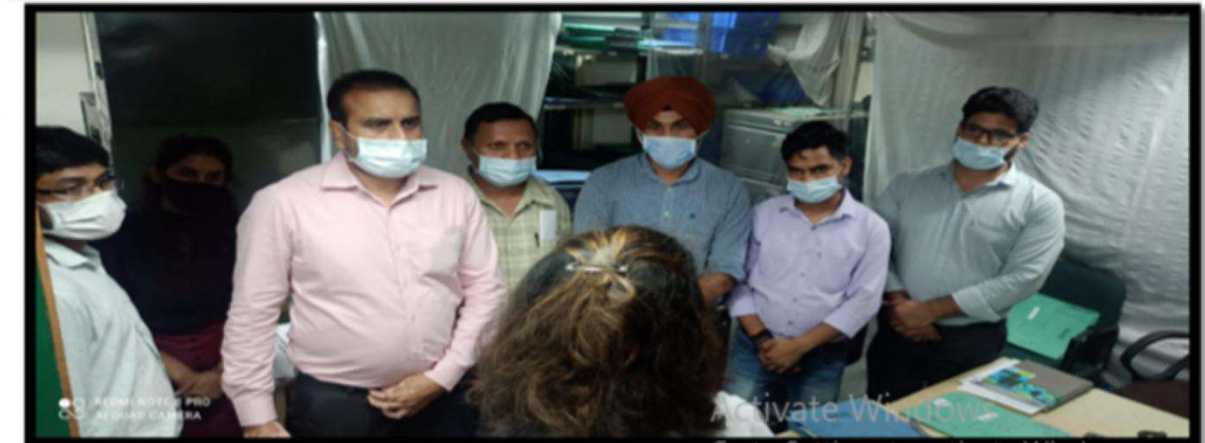
Debriefing done by Dr. Shweta Prabhakar, Head Quality & Patient Safety  
Post Code Red Mock drill
